Degradation Monitoring of Low-voltage Electromagnetic Coil Insulation Based on Microscopic Image Analysis

Keywords—low-voltage electromagnetic coil, insulation degradation monitoring, microscopic image analysis

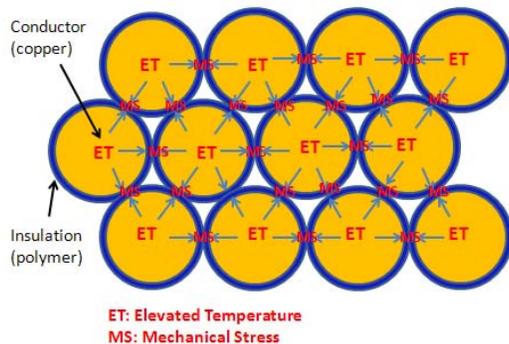
Fig. 1. Cross-sectional view of a multi-layer winding.

A cross-sectional view of the coil is shown in Fig. 1. The wire used is generally referred to as magnet wire, which is constructed of conductor (usually copper) coated by insulation material (usually made by some kind of polymer). Failure analysis of coil insulation is described as follows. As an electric current is passed through the wire, Joule heating causes an increase in the wire temperature and the expansion of the conductor, placing mechanical and thermal stresses on the insulation [17,18]. Thus, the elevated temperature combined with the mechanical stresses will lead to insulation degradation. Further, because the dielectric material between the wires degrades, its mechanical strength decreases and the turn-to-turn or layer-to-layer insulation layer will be extruded and deformed under the mechanical stresses, resulting in a turn-to-turn or layer-to-layer short. The short can cause the coil resistance to decrease, thus pulling a greater current into the valve. At the location of the short, a hot spot can form, where the local temperature is great enough to cause the wire to burn out, resulting in an open circuit, and finally, failure of the complete coil. This paper focuses on the coil insulation degradation process, which is referred to when the turn-to-turn or layer-to-layer short has not formed yet. A novel insulation degradation monitoring method will be proposed in the next Section, which presents opportunities for predictive maintenance for motors, SOVs, transformers, and the like.

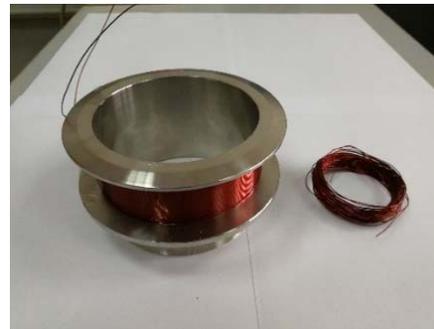
Fig. 2. A hand-wound coil and magnet wires under test.

Because thermal stress is the dominant aging factor for electromagnetic coils, a thermal deterioration test was performed to provide specimen with different degraded status for microscopic image analysis. In detail, a hand-wound coil and magnet wires, as shown in Fig. 2. were placed in a test chamber set to 235 °C. The specimen's information is shown in Table I. The deterioration cycle is set to be 18 hours. After each deterioration cycle ten small sections of magnet wires were cut from the magnet wires and microscopic images of their appearances were acquired by an optical microscope, as shown in Fig. 3. Further the DC resistance (DCR) of the hand-wound coil was measured by a multimeter to indicate if turn-to-turn short has occurred. The DCR measurement result was shown in Fig. 4. The DCR kept in around 3.15 ohm in the first 3 cycles while dropped to 2.95 ohm at the 4th cycle, which means that the turn-to-turn short has occurred. Therefore, the aging time of this experiment was set to be 72 hours. Then, magnet wire specimen with different degraded status, which were obtained by the 72 hours thermal deterioration test, were fixed to glass slides for optical observation, as shown in Fig. 5.

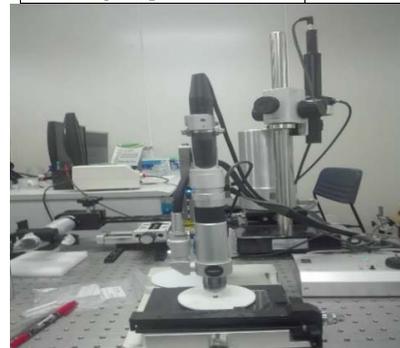
Fig. 3. Optical microscope measurement platform.

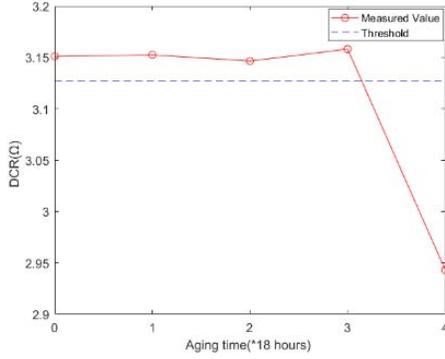
Fig. 4. Coil DCR measurement result during the thermal deterioration test.

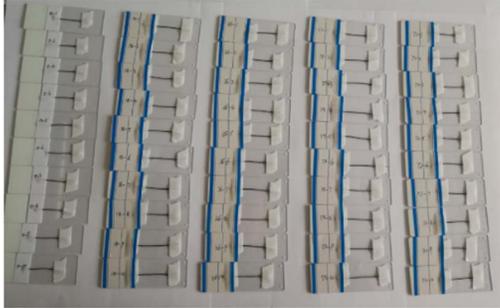
Fig. 5. Specimen of the magnet wires with different degraded status for optical observation.

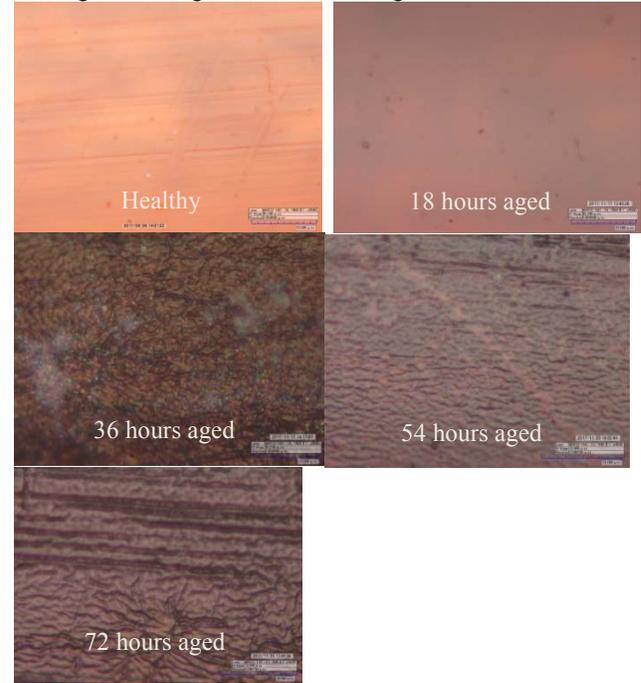
Fig. 6. Representative microscopic images of the magnet wire specimen in each deterioration cycle.

The representative microscopic images of the magnet wire specimen with different deterioration status, which were acquired by the optical microscope, were shown in Fig. 6. Microscopic image analysis was applied in order to provide quantitative information on the appearance change during the deterioration test. As shown in Fig. 7, first, image pre-processing was performed to localize the main body of the objects to be analyzed on the original microscopic images. Second, the following three color features from 3 different color spaces, namely, RGB, HSV and HSL, were extracted respectively for each image: (1) Color feature in X-direction, which is defined as the sum of gray levels of every column in the image to be analyzed; (2) Color feature in Y-direction, which is defined as the sum of gray levels of every row in the image to be analyzed; (3) Global intensity, which is the pixel density with a certain gray level in the whole image. Finally, the similarity was defined to quantify the difference between healthy and degraded images for each color feature from these 3 color spaces. Similarity is calculated based on the Euclidean metric between the feature vectors of healthy and degraded images and after normalization it is defined as

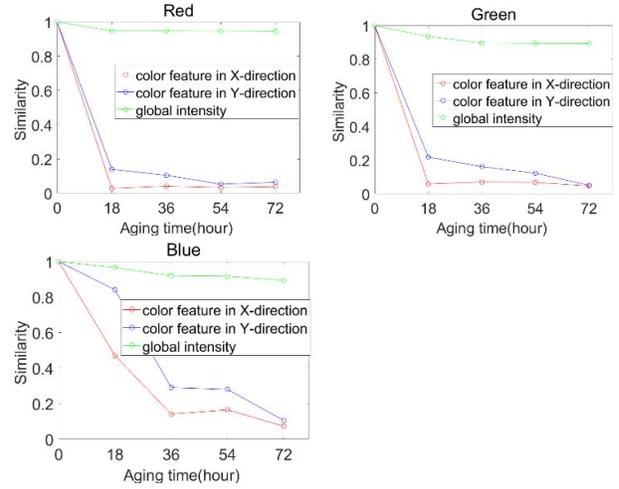
Fig. 8. Correlation between similarity and aging time for color features from RGB color space.

The calculated results for the similarity between healthy and degraded images from different color spaces are shown in Table II, III, and IV, which provides quantitative information of differences between healthy and degraded images. As for each color space, the correlation analysis between each color feature from the corresponding color channel and aging time is performed and the results are shown in Fig. 8, 9, and 10, respectively. Thus the evolution of the color features as the insulation degrades can be explored. In each color space, there are some specific color features, like the global intensity for Green channel from RGB color space, showed a monotonic decreased trend during the thermal deterioration test, which demonstrates that these color features are degradation-sensitive. All these degradation-sensitive color features can be used as potential health indicators for insulation degradation monitoring for coils, which are summarized in Table V.

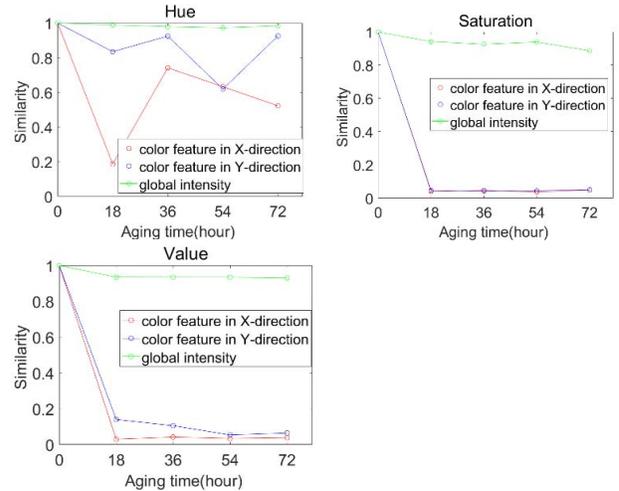
Fig. 9. Correlation between similarity and aging time for color features from HSV color space.

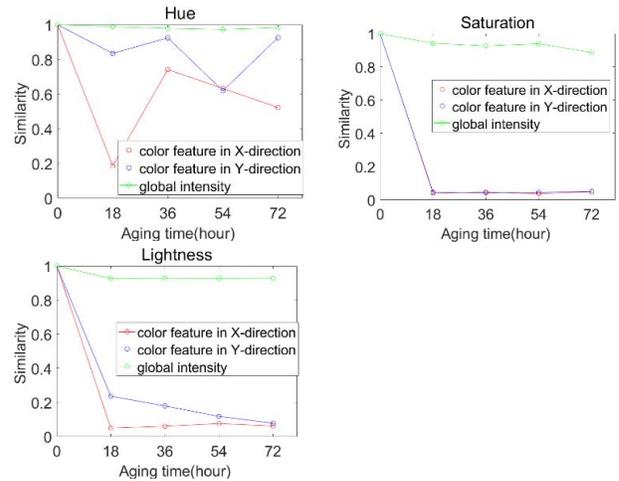
Fig. 10. Correlation between similarity and aging time for color features from HSL color space.
